Kurume History Walks

No.16 Former Mishima Family Gate Kyu Mishimake Nagayamon 旧三島家長屋門

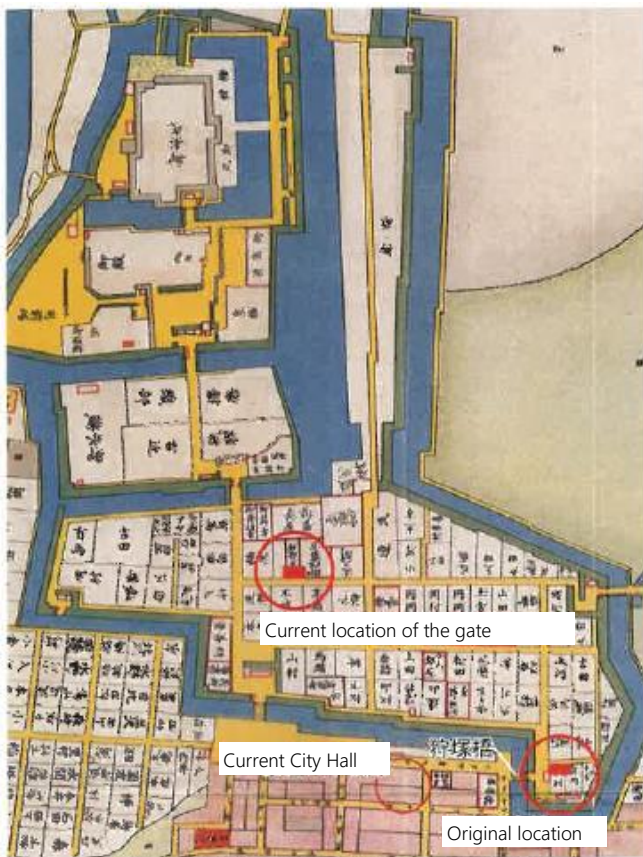
Map of the castle and the town in the Tenpo era (1830-1843)

Former Mishima Family Gate

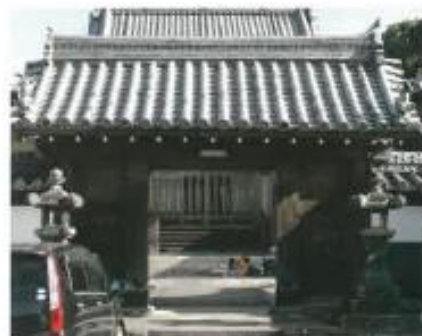
Yakuimon of Myoren-ji Temple

The Myoren-ji Temple at Teramachi uses a *yakuimon* that originally stood at the residence of a chairperson of domain finance. The gate is said to be relocated to the present place at the time when he was punished by seizing assets in 1845.

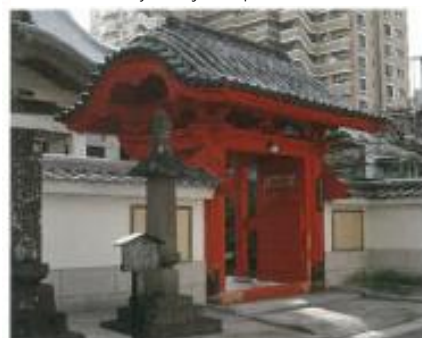
Karamon of the Hontai-ji Temple

The Hontai-ji Temple at Teramachi has a *karamon*, which is the oldest among others in the city.

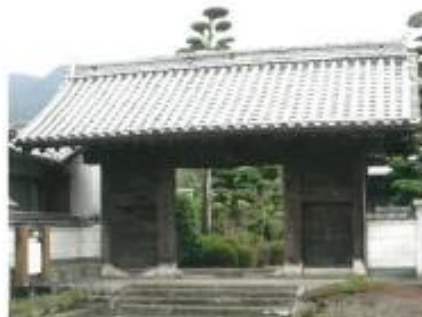
Yakuimon of the Juhoni-ji Temple

The Juhon-ji Temple at Kusanomachi received a gate of Kurume Castle, which took the style of the *yakuimon*. We consider that it was moved after 1873 when the castle was dismantled.

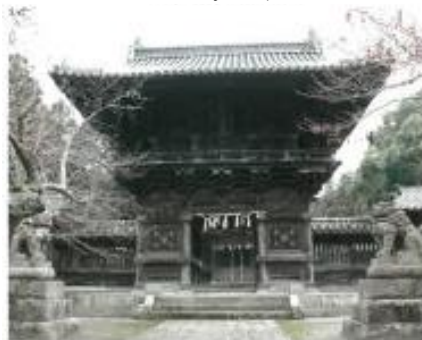
Roumon of the Susano-jinja Shrine

The Susano-jinja Shrine's *roumon* has elaborate carvings of the mixture of the styles derived from India, China, and Japan.

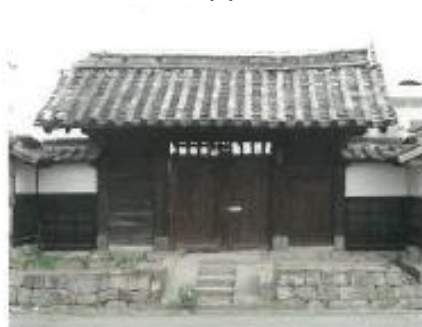
Yakuimon of the Sasaki family

The photo at the bottom shows a *yakuimon* which does not exist anymore. The Sasaki family owned it at Jonanmachi. During the Edo period (1603-1854), the size and the type of the gate to construct were determined by the status. This gate is ranked as the middle.

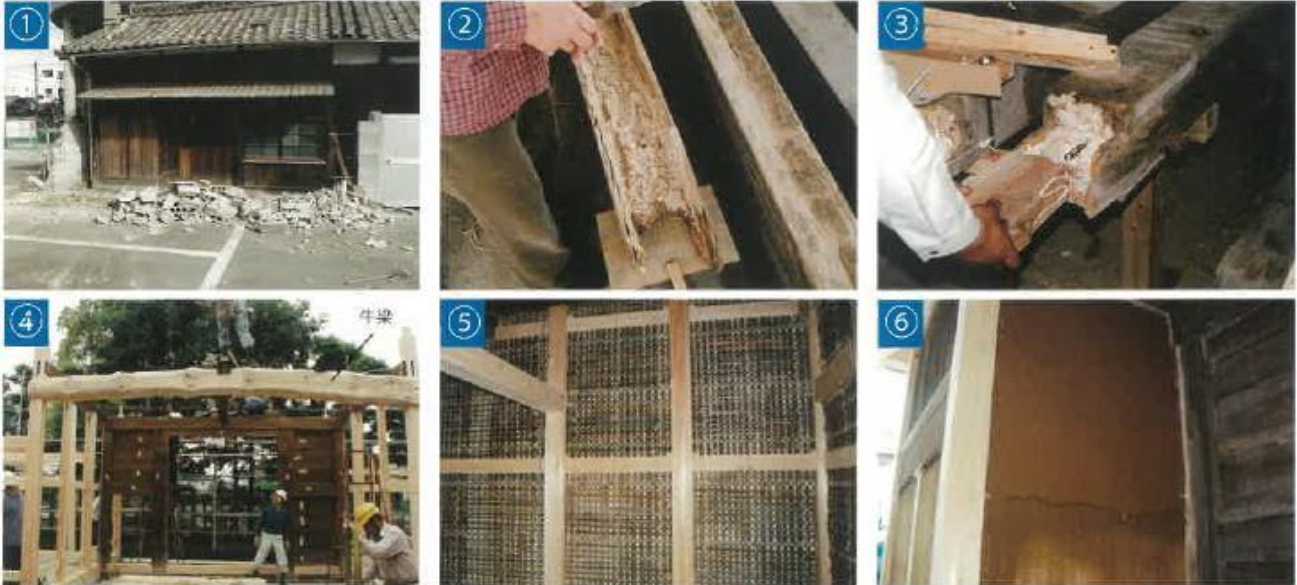
- ① Just before the dismantlement. It shows how the gate was.
- ② Damaged pillars because of the termite and the corrosion. We cut off unusable parts and reused them by adding the reinforcement.
- ③ Reinforcement of a mortise with new wood.
- ④ Raising the framework. It is distinguishable between the reused timbers (brown) and the new (beige).
- ⑤ This bamboo lattice is the foundation of the earth wall.
- ⑥ The wall covered with clay.
- ⑦ We found the inscription on wood during the dismantlement. This made clear the construction period (1840) and the carpenter (Mimaki Ichizemon, a purveyor to the Kurume Domain)

From 2001 to 2002, we carried out relocating and repairing work. The original timbers from 1840 have remained despite many times of the restoration since the first time in 1917. The large part was corroded because of the termite damage, although we repaired them using as large as possible.
