# Kurume History Walks

## No.7 Exploring the Ancient Roads 古代道路を掘る

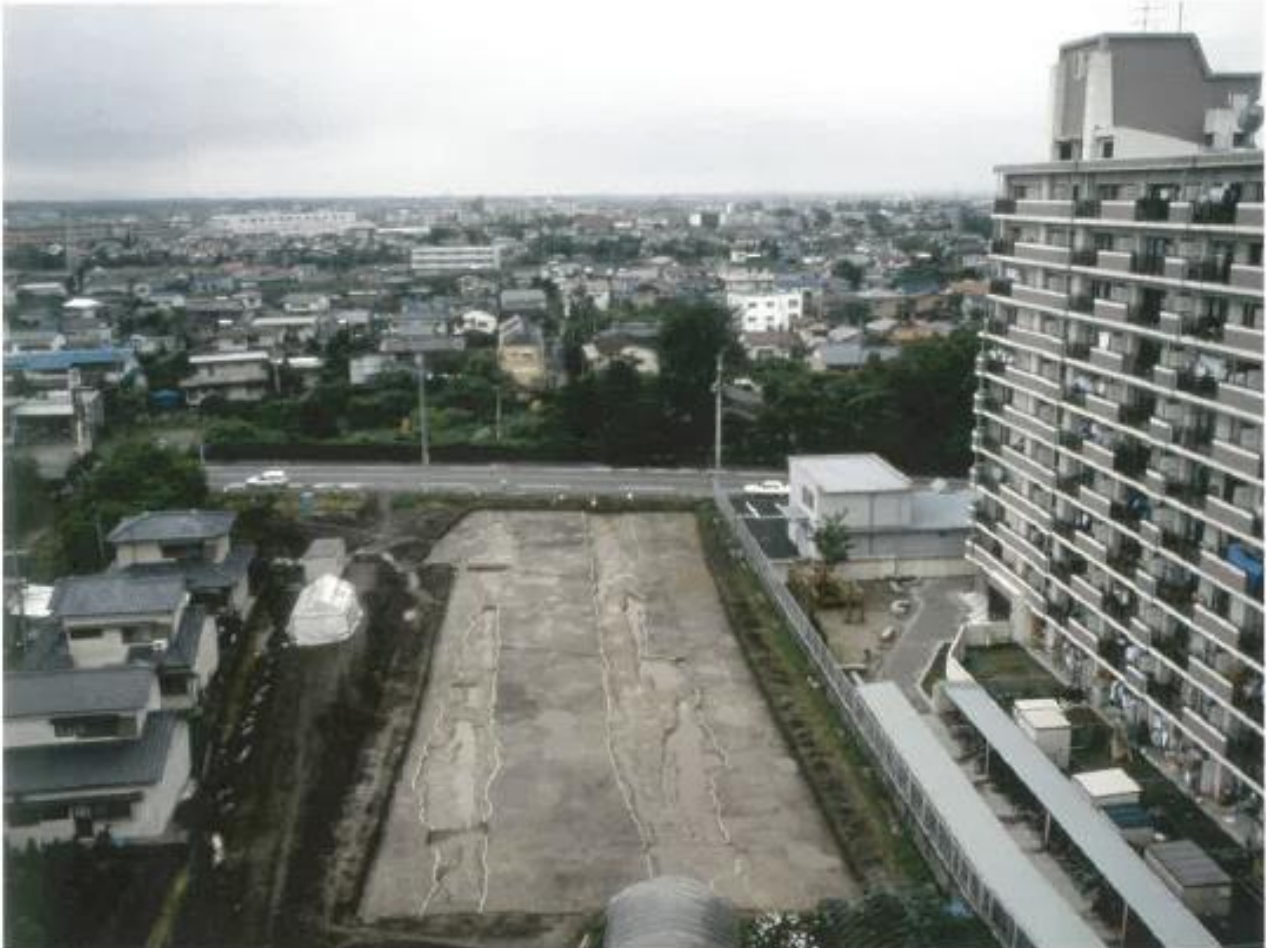
In 1992, the investigation started on this site. It is the remains of Saikaido. Here, we researched 70 meters of the road. The ditches (street drains) should have been dug many times, so its shape is unformed. We estimate that it was over 7 meters wide and was used between the 8th and 11th centuries. The soil and gravel that were used to pave a road remained.

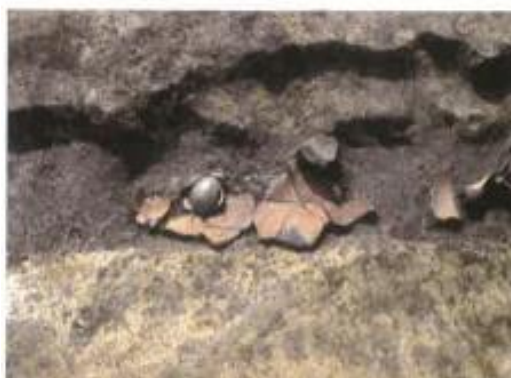
Many earthenwares were discarded in the street drain. These are mainly from the 9th century.

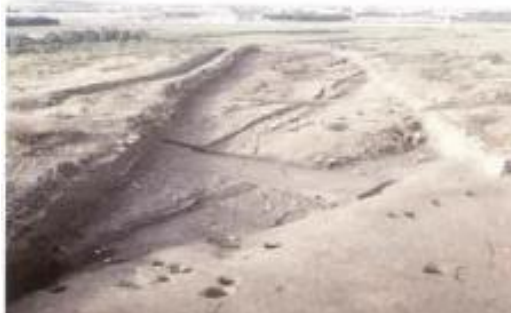
*Denro* road next to Hebonoki remains: paved with stones, narrow and winding.

The Hebonoki remains (3 on the map of the previous page) were reportedly an administrative office or a temple. These faced the T-junction of the *denro* and a major road that passes through Chikugo provincial capital (*kokufu*). The construction period is not clear but we suppose it to be abandoned in the 12th century.

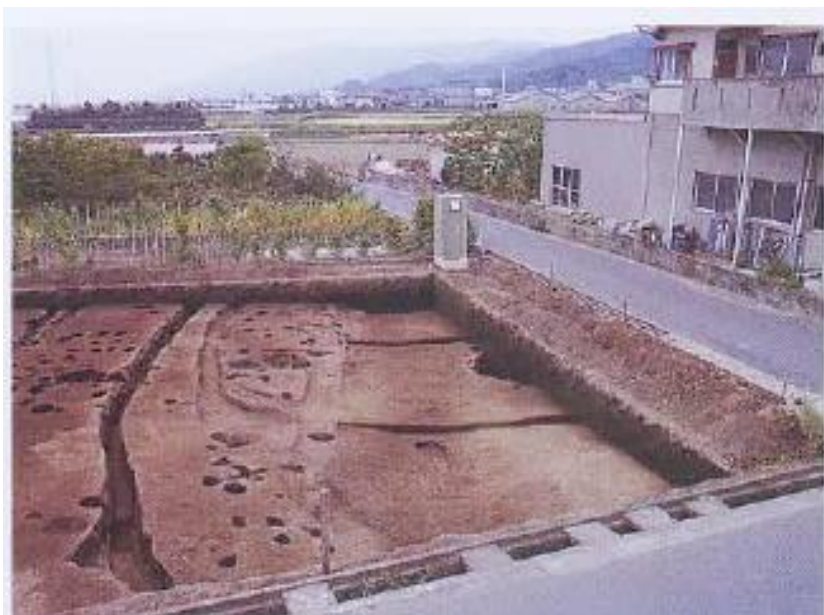
The remains of the *Kokufu*  
The Ancient Road passes beneath the present road. By the Cut Slope method, the surface is a little depressed.

**Cut Slope:** A road building method at a low hill by shallowly cutting a slope.
